TECHNICAL BULLETIN

TB001235

Titre : Démontage de la sécurité de porte Istantaneo

Toutes les machines à laver et lavante séchante Ariston / Hotpoint avec sécurité de porte Istantaneo

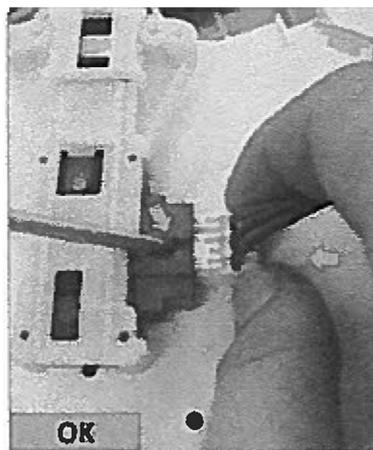
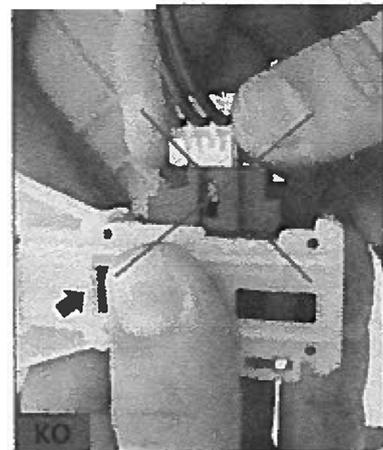
Le démontage du bloc de verrouillage de la porte doit être fait avec soin afin de ne pas causer des fissures dans le bloc de raccordement d'étanchéité.

1. L'opération de démontage du connecteur est faite en utilisant un petit outil (ex : un tournevis) pour libérer le connecteur de la sécurité de porte, sinon il pourrait rompre le crochet du connecteur

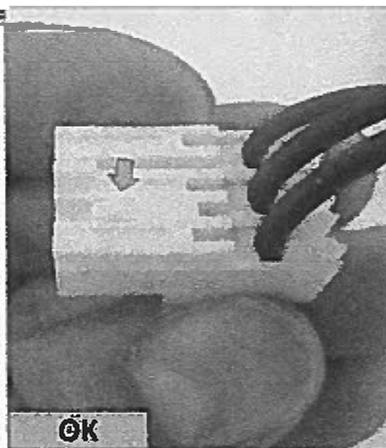
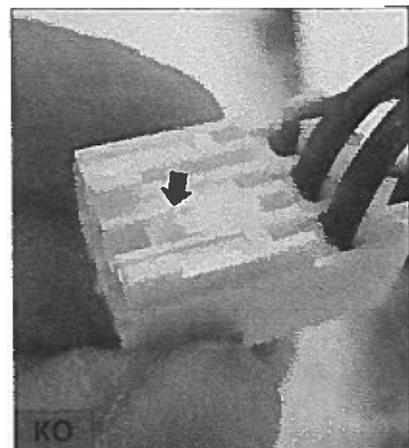
2. Avant d'insérer un nouveau connecteur, vous devez vérifier que le crochet ne se décompose pas. La rupture du joint crochet peut entraîner le détachement du lien de raccordement et le dysfonctionnement de la machine.

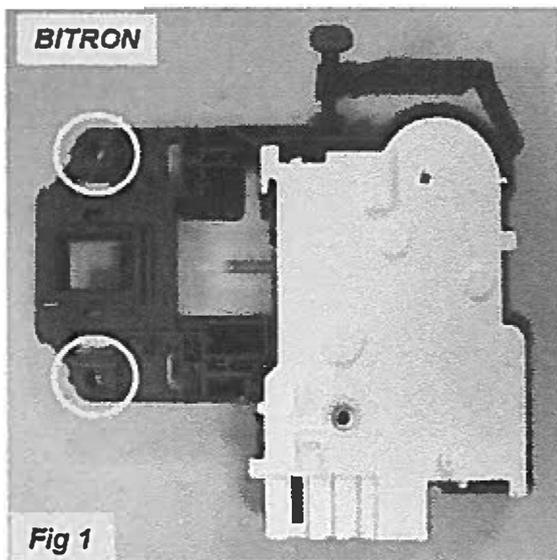
The original (Bitron Type) interlock *Fig 1* is secured to the front panel by 2 x T15 screws (C00065185).
The alternative (Rold Type) interlock *Fig 2* is held in place on the front panel by 2 x plastic locating pips.

These door interlocks are interchangeable
